## Erosion Mapping Based on Erosion Evidence Features in the Micro Watershed of Parangtritis

*This study involves detailed observations of erosion indicators within the watershed to produce a comprehensive mapping of erosion patterns. The detailed mapping of erosion patterns and spatial distribution, along with the factors influencing erosion, is essential. Mapping erosion spatially often yields data that may differ from the actual erosion conditions observed in the field, there is a need for a more accurate yet efficient mapping of erosion hazard levels by combining spatial analysis methods and field surveys. The primary focus of the research is to develop an efficient erosion mapping survey procedure at the Micro Watershed Scale, considering diverse erosion typologies and land-use dynamics. The Micro Watershed of Parangtritis, chosen for its unique erosion characteristics, was used as the main research area. This mapping method involves a combination of field surveys and geospatial analysis to capture various erosion features. Important data to collect are various erosion and landform features based on their geomorphology and anthropogenic features. The mapping results demonstra

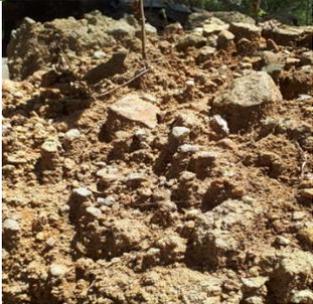
No	Features of Erosion	Image	Description
1	Splash Erosion

Splash erosion indicates very light erosion hazards. Splash erosion can be observed after rain as they are easily washed away without significant human activity. Sheet erosion in residential areas is more challenging to identify, even a day after heavy rain, due to human activities that may trample or be compressed by vehicles. Meanwhile, splash erosion can still be found in some home gardens.
2	Sheet Erosion

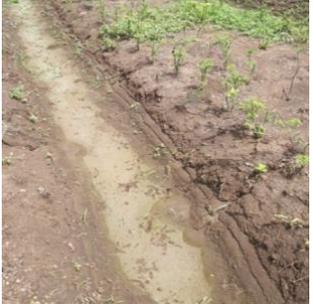
As splash erosion stage evolved into sheet erosion stage, the erosion rates and hydrodynamic characteristics during these two stages are obviously different, which certainly leads to the differences in the processes of soil detachment, sediment transport, and sediment deposition. The impacts of erosion caused by sheet erosion are not as severe as those caused by rill and gully erosion. Sheet erosion can be observed after rain, and was found in the middle part of watershed, specifically in agricultural areas.

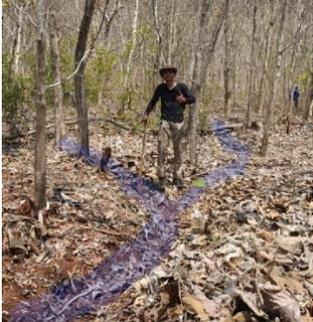
3	Rill Erosion

In upstream areas, rill erosion is prevalent and serves as an indicator of soil erosion intensity by water. Rill density, influenced by factors like rainfall, soil structure, slope, and land management, correlates with erosion impact on soil layers. High-density rill erosion can lead to loss of fertile soil, hampering plant growth and increasing downstream flooding risk. Continuous erosion alters soil texture, reduces water infiltration, and contributes to land degradation. In karst regions, unique runoff and erosion processes occur due to the thin soil layer and dual hydrogeological structure, differing from non-karst areas (Fang et al., 2022, Fu et al., 2016).

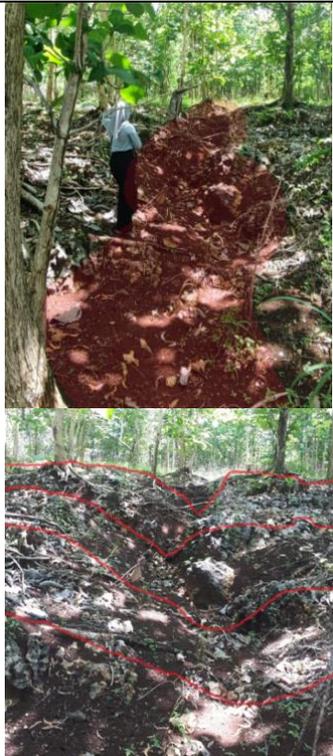
No	Features of Erosion	Image	Description
4	Gully Erosion

<p>Gully erosion is commonly found in the upstream part of the watershed. The depth of the gullies, reaching up to an adult, indicates high erosion hazard in that area. The thin soil on the surface of the channel network is the result of erosion transport during rainfall.</p>
5	Rock Fragment

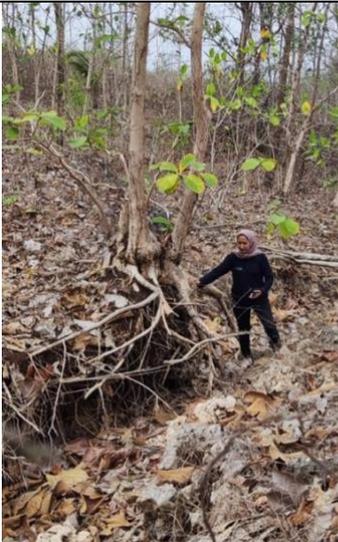
<p>The research location in the central part of the watershed with very steep slopes, wide and deep gully erosion, exhibits a condition where tree roots are entirely exposed to a considerable depth. It is evident that these tree roots are still attempting to stabilize the soil and prevent landslides.</p>
8	Sediment Deposit

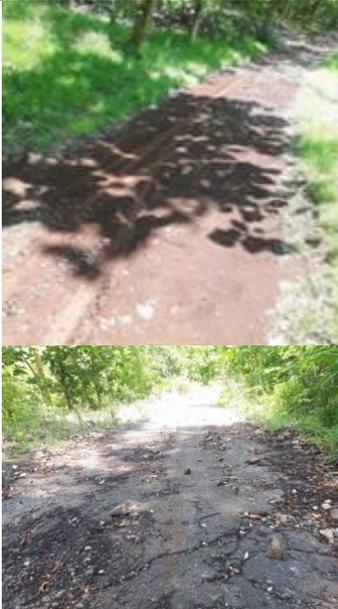
<p>Sedimentation and deposits in certain areas, especially those receiving runoff from slopes, are indicators of high erosion hazards in the upstream region.</p>
9	Erosion and Infrastructure

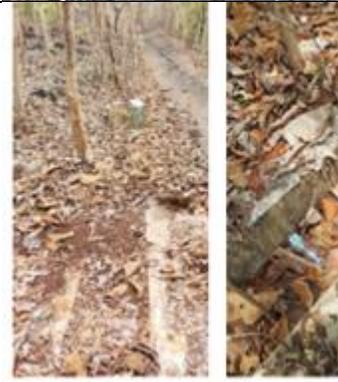
<p>This indicates that erosion also affects infrastructure, particularly in water channels. The erosion transports soil particles from higher areas to lower ones. Water channels function as drainage to convey rainwater from the surface, indicating the presence of runoff from the surrounding area. High erosion occurs in this area, capable of transporting sediments and depositing them in the water channel until it becomes full. In locations with lower erosion risk, it is observed that the water channels are not covered with sediment.</p>

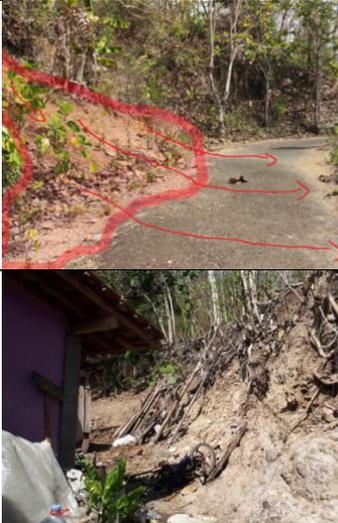
<p>Landslides can block road access, posing a danger to humans in the backyard as they are very close to residential buildings.</p> <p>Many teak trees have been cut down at the top of the cliffs, but their roots remain in the soil. These remaining roots have aesthetic value, and many people attempt to collect them for bonsai or decorative purposes. Local residents have prohibited such activities, but illegal harvesting still occurs frequently.</p>

The kinetic energy of rainfall and the easily transportable soil condition indicate that erosion has reached the catastrophic stage. Infrastructure damage is severe, including severe road damage, destroyed riverbanks, sedimentation in water channels, and landslides on the slopes. Landslides can block road access, posing a danger to humans in the backyard as they are very close to residential buildings.
